INTERIOR CURB FLASHING (TYPICAL)

TN-C1

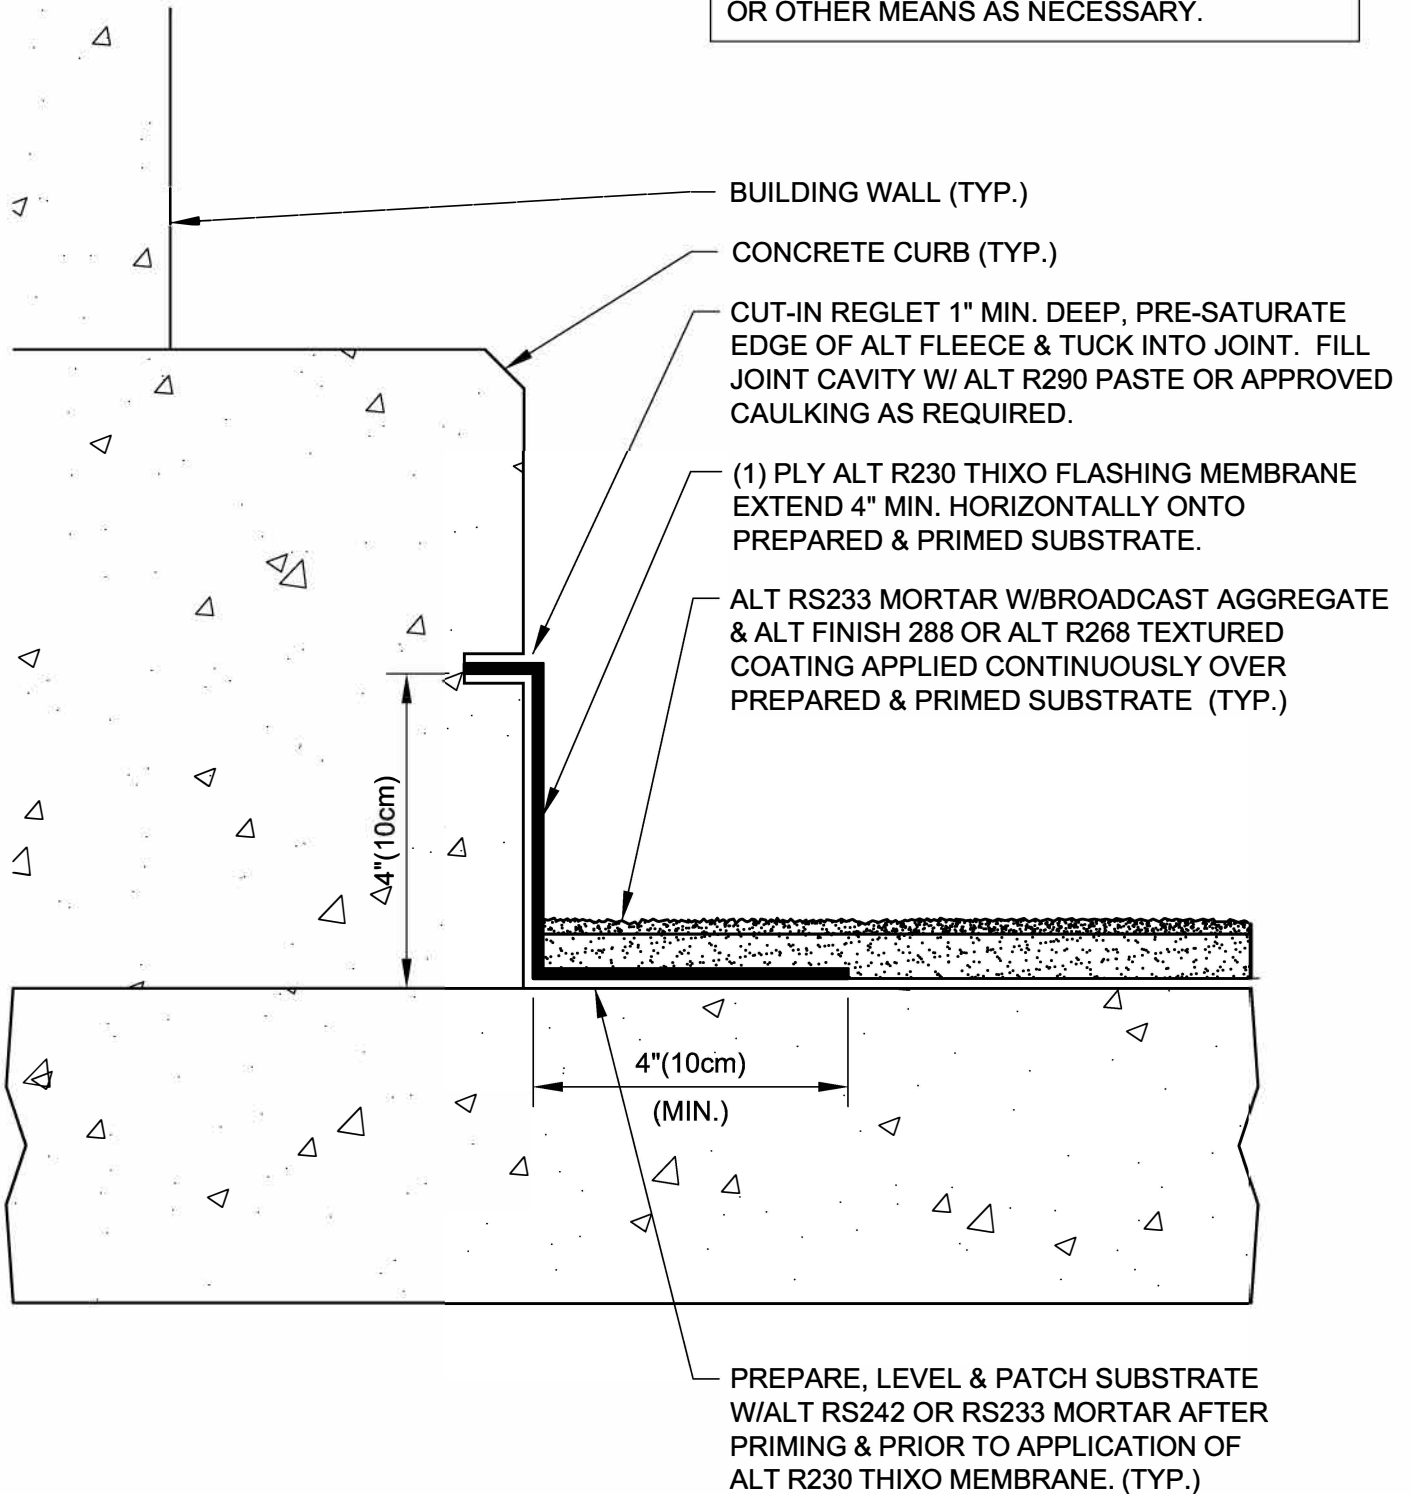
ALT R230 THIXO FLASHING APPLIED ON CURB IS SUBJECT TO MECHANICAL DAMAGE FROM VEHICLES & SHOULD BE PROTECTED USING BOLLARDS, STAND-OFFS & STEEL SKID PLATE OR OTHER MEANS AS NECESSARY.
